Catching Up On Culvert Repair

Oregon Department of Transportation tests trenchless solution

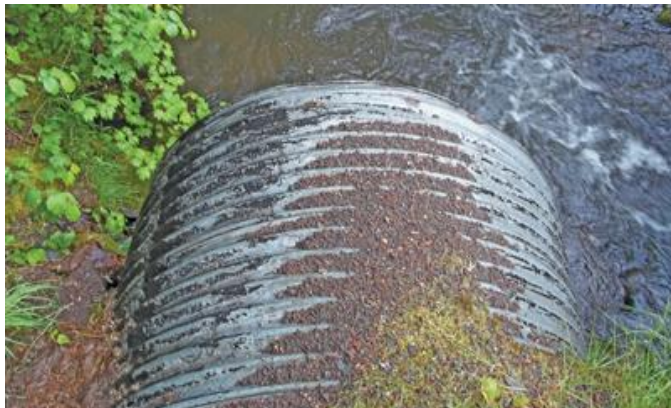
The 526-ft overflow culvert runs parallel to the west side of the highway and is made of 72-in. corrugated metal pipe.

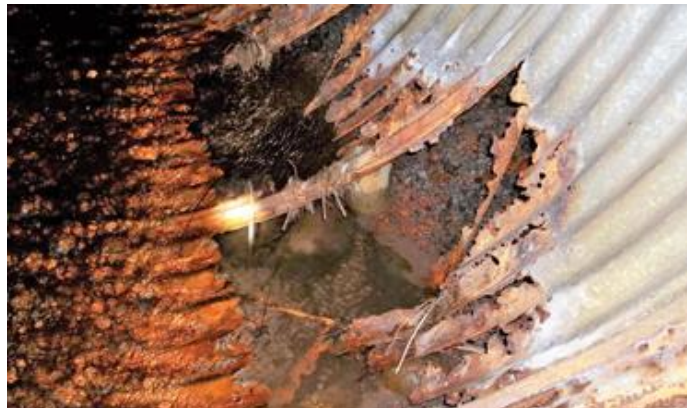
“When we actually got in the pipe and took a look, we found that it was worse than we thought,” Gunther said. Inverts were near failure or completely rusted out, and large voids were visible behind rotten patches for most of the culvert’s length. Oregon’s famous storm events also took a toll; rocks and sand pushed along by occasional high-velocity flows had damaged the CMP.

Before rehabilitation, the corrugated metal pipe showed signs of physical damage due in part to storms and debris pushed through by high-velocity flows.

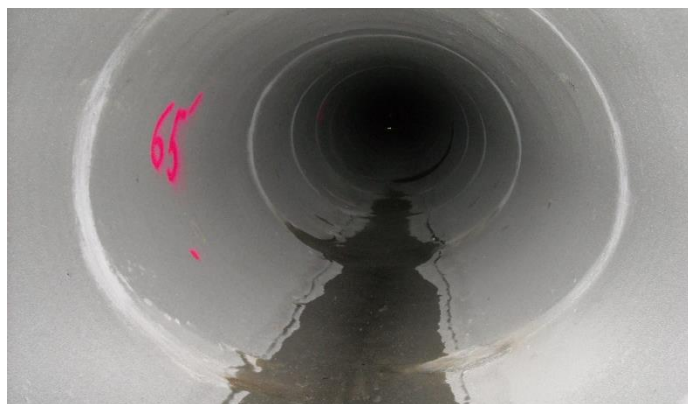
Rehabilitated pipe is smooth, seamless, structural, and watertight

SunCoast set up on a patch of ground, about 20 by 8 ft, by a drain near the middle of the culvert. This highlights another advantage of CentriPipe; staging areas are relatively small, compared to competing solutions. By inserting the SpinCaster in the middle drain, SunCoast was able to work from the ends of the culvert to the drain. Two passes were required, each laying down a 0.5-in. layer.

volume of material applied. On this project, SunCoast applied two layers, and total thickness was an inch above the CMP corrugations. Due to the infiltration issues, total time on site was almost a month, but actual spray time was just more than a week.
