A Rude Surprise That Turned Out Surprisingly Well: Rockland NY Sewer District Innovates in a Hurry to Make Critical Repair

by Angus W. Stocking, L.S.

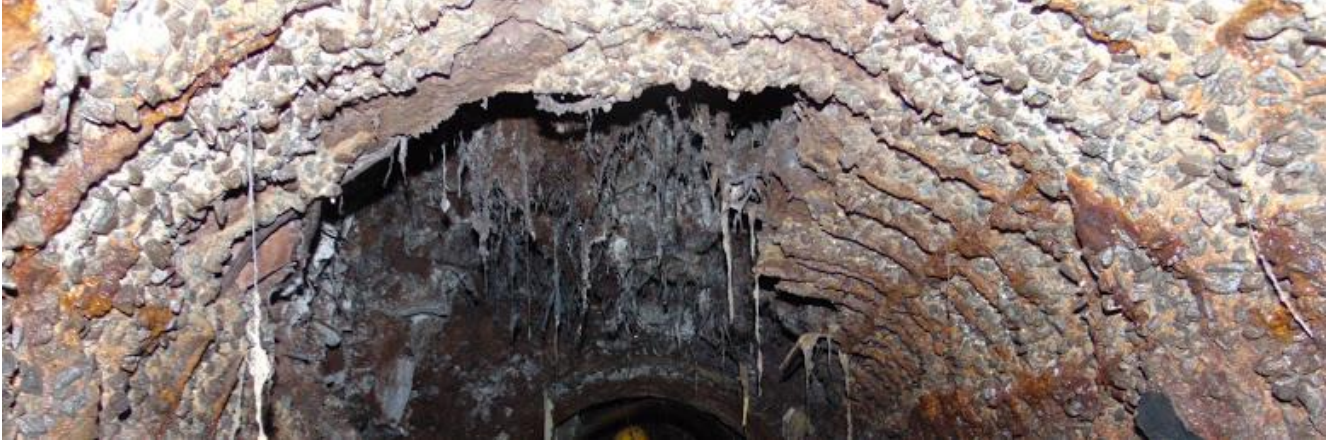
Top half of interceptor, completely rotted out and held in place by root masses

A routine five-year inspection of a 36” reinforced concrete pipe (RCP) sewer interceptor in Rockland County (NY) Sewer District No. 1 revealed a rude surprise for Engineer IV Martin Dolphin P.E.—CCTV showed that the top half of the interceptor, which had been in good shape just five years previously, was almost completely rotted out by microbiologically-induced corrosion (MIC). Even the reinforcing rebar was gone in 20-30 foot stretches of the 750 lf sewer and the only factor preventing complete collapse appeared to be solid root masses that held soil in place.

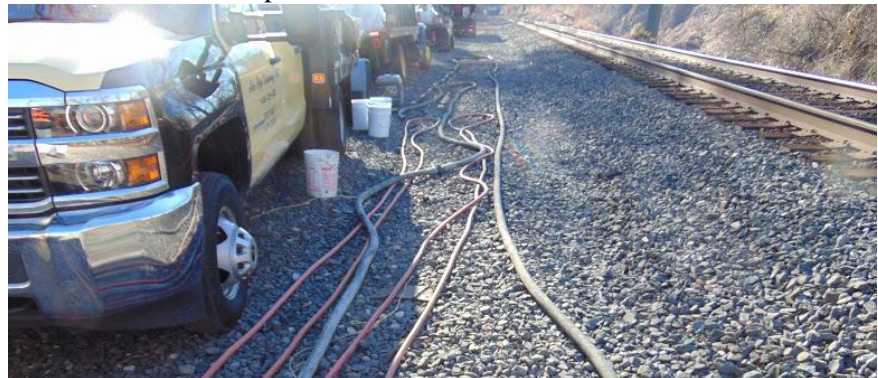
most of the District’s network feeds into it—a failure here would affect hundreds of homes and businesses. So a rehabilitation was definitely needed, and due to the extent of the corrosion it had to be structurally sound. This ruled out CIPP, and would ordinarily have been addressed with trenching and new pipe, despite the cost and inconvenience. But another confounding factor seemed to rule out trench-and-replace. “This interceptor runs parallel to a railroad track, within the railway easement, and also crosses under two roadways,” Dolphin explains. “That meant permitting issues for trenching could push back

Interceptor site running parallel to railroad tracks and underneath two roadways

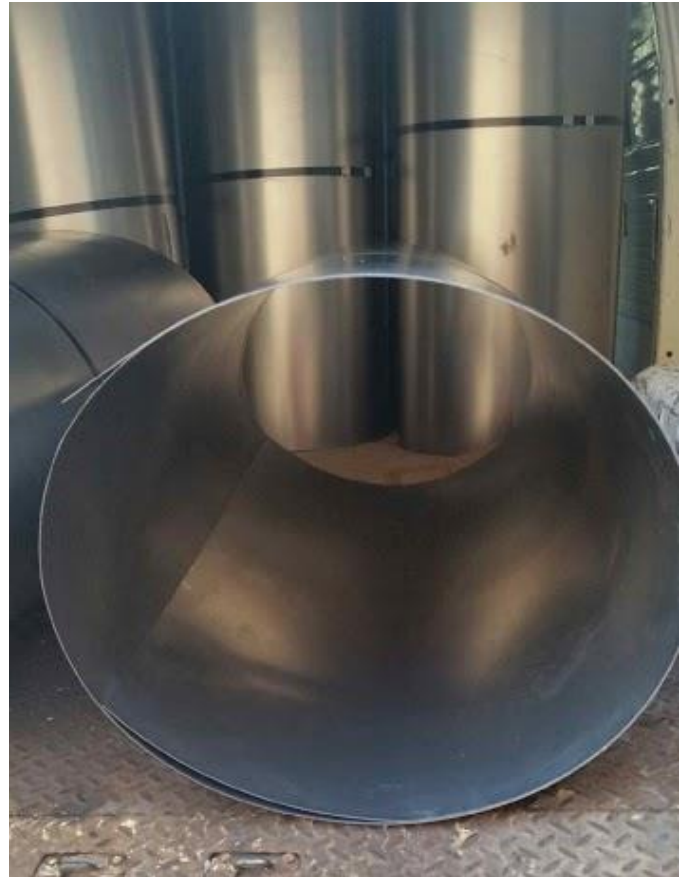
Custom sheet steel inserts to be inserted into failing interceptor

Working with a local fabricator, Lounsbery made long tubes of sheet steel, with lengths customized to the voids shown on CCTV, which were rolled up and banded to a tight 24-inch diameter. These were inserted from

manholes and pulled to the areas of exposed soil. Once the tubes were in place, the constricting bands were cut so the rolls of steel could expand to the full 36-inch pipe diameter, and secured in place with rivets and masonry anchors. And voilà—a fully stable pipe substrate was created at low cost, in just five

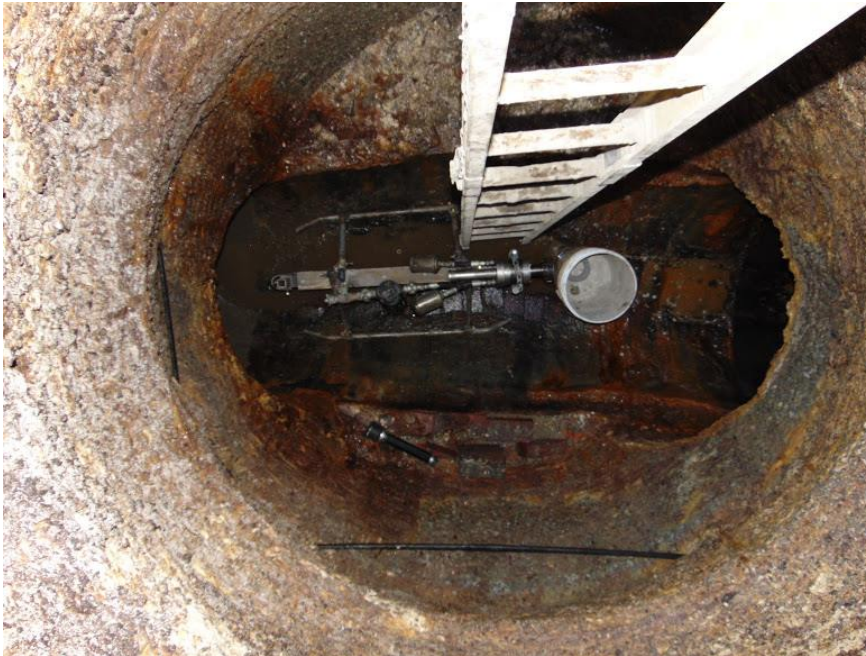
Manhole entry for rehab installation

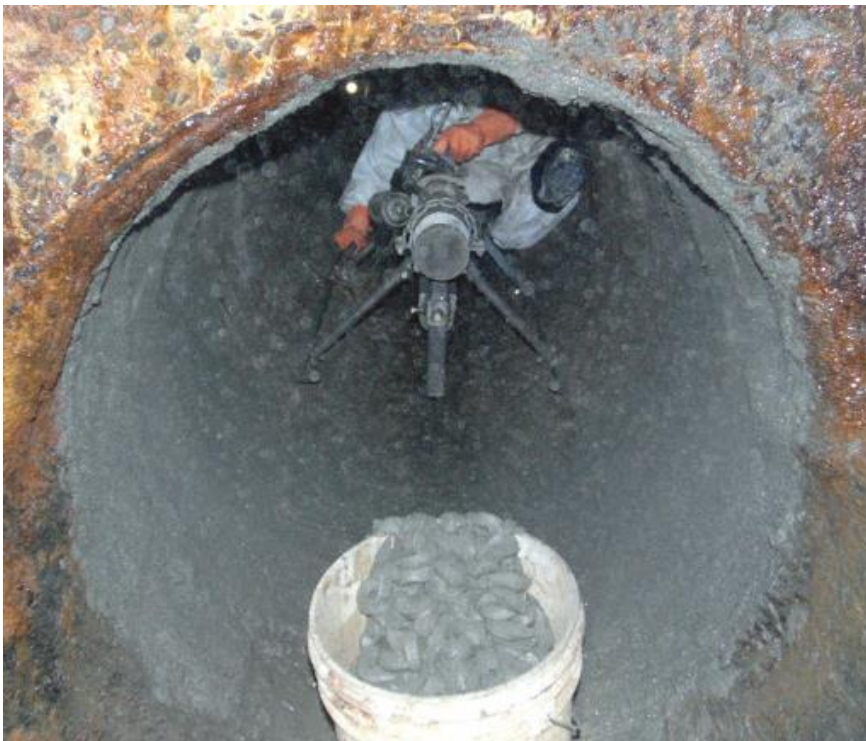
Spin-casting onto sheet steel inserts for fully structural rehabilitation of interceptor

diversion to a parallel sewer and, working from manhole to manhole, an inch-and-a-half thick concrete pipe was cast in three half-inch passes. “This was actually conservative,” Lounsbery

says. “The engineered design called for a one-inch pipe, and we decided to exceed that to eliminate any possibility of collapse, and for peace of mind.” Less than two weeks was spent on actual CentriPipe application—layer application is fast, and since PL-8,000 cures quickly, layers can be applied on successive days. This time also included soil compaction and backfilling from above, after CCCP work was completed.

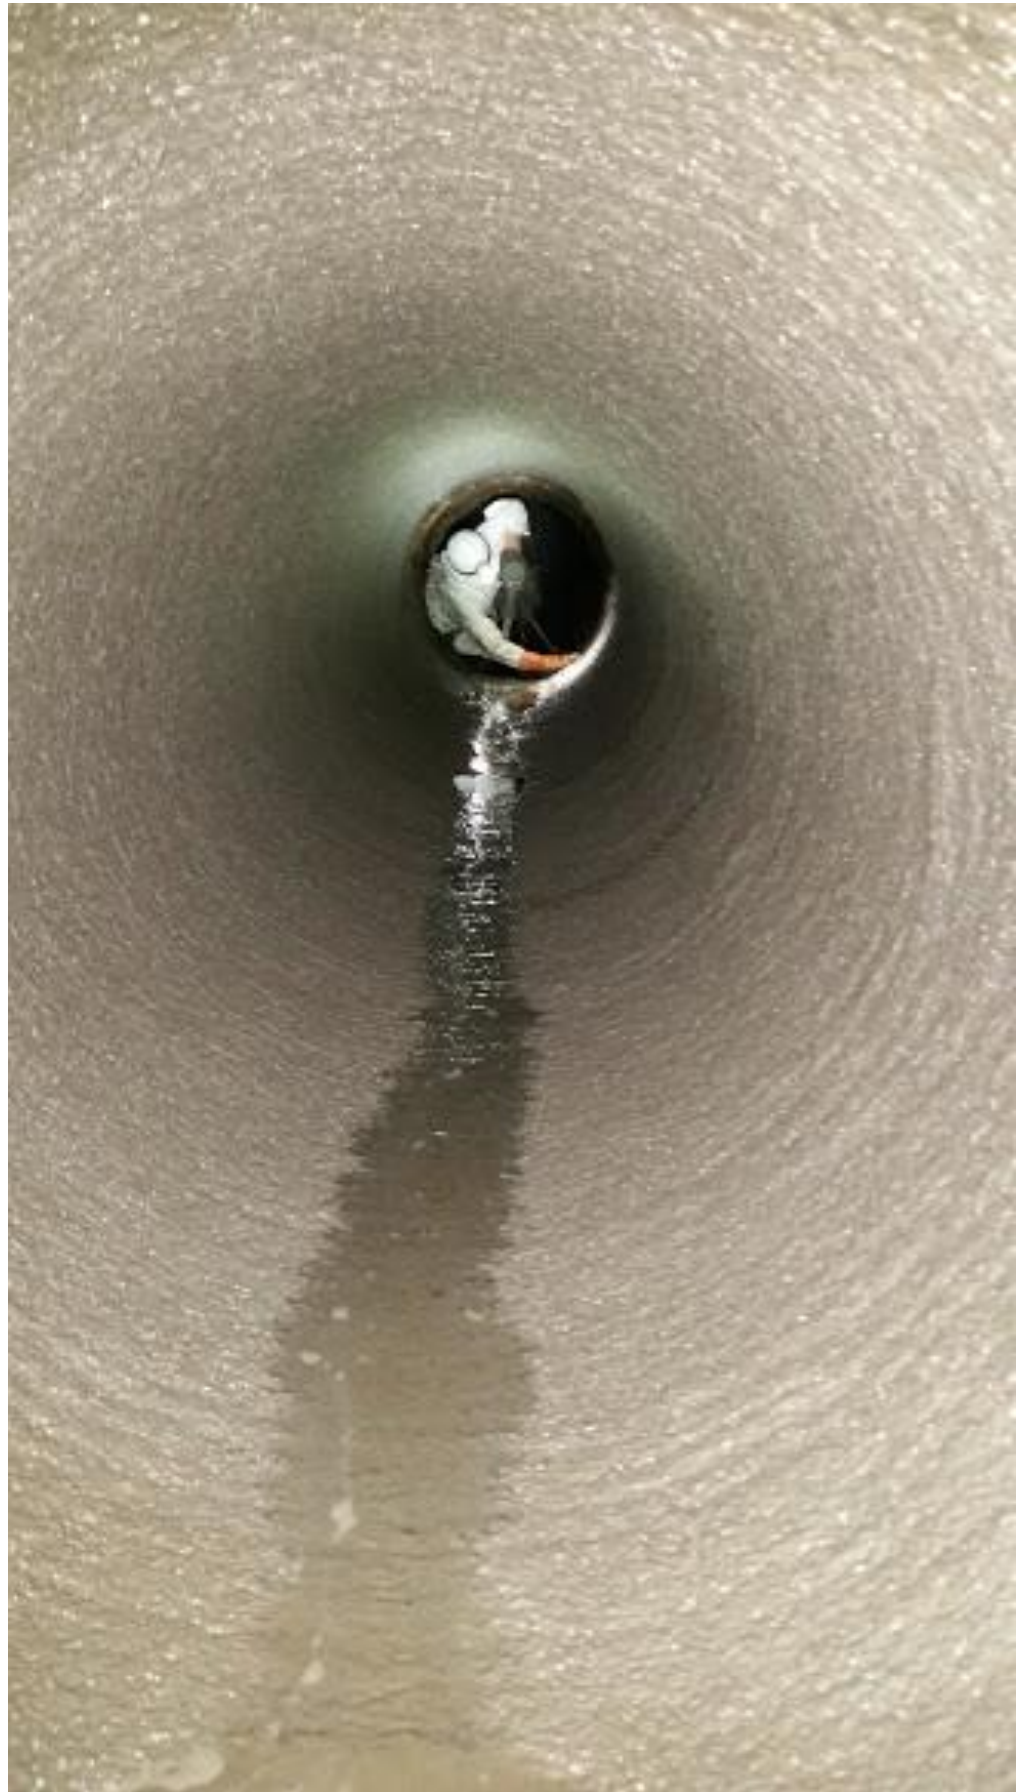
Fully rehabilitated interceptor
