# Still Going Strong 17 Years Later: Successful Sewer Structure Rehabilitation

## Project combines Permacast® with Con<sup>MIC</sup>Shield® to Repair AND Prevent Damage from MIC

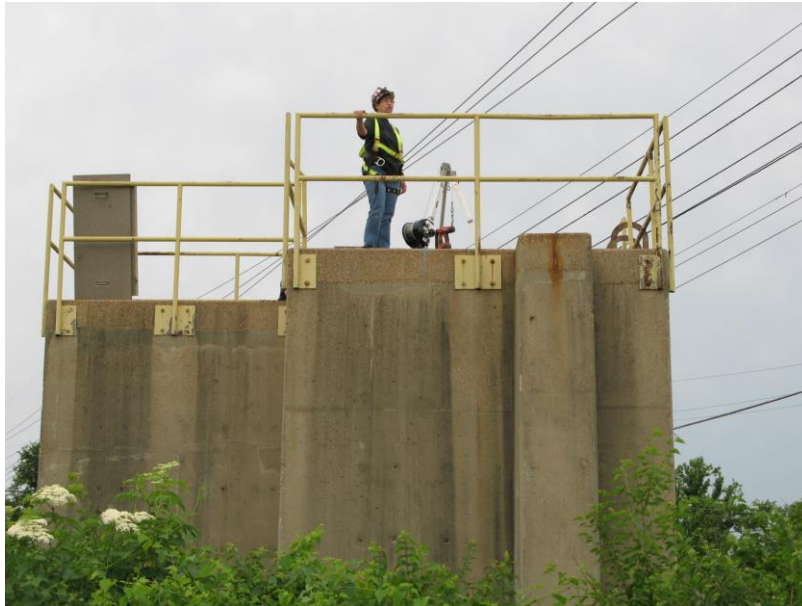
The results were dramatic. The upper portions of the shaft had

been eaten away about two inches, and surface layers were mushy. Toward the bottom, more than five inches had been eaten away, walls were mushy, and supporting steel was exposed and corroded. Quite literally, this was a disaster waiting to happen.

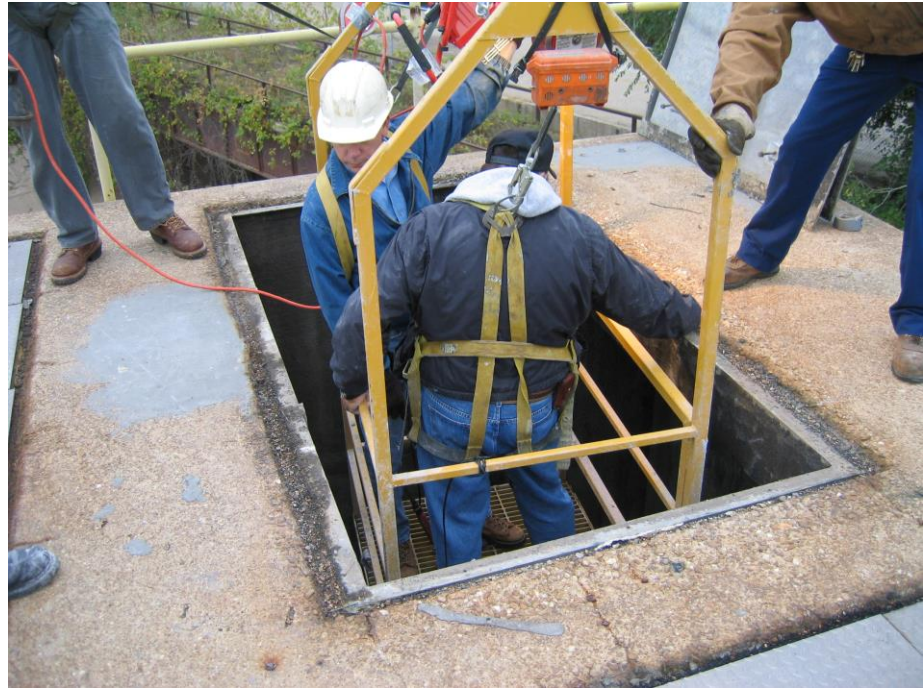
- Power washed the walls back to solid material
- Installed wire mesh to the walls for structural reinforcement of the worst areas

- Applied several one-inch layers of MS-10,000, a high-strength cementitious grout developed by AP/M PERMAFORM and fortified with Con<sup>MIC</sup>Shield®
- Troweled the surface after each layer was applied to ensure a densely-compacted, uniform finish
- Troweled smooth a final one-inch layer once the entire wall was rebuilt to the plumb line

And basically, that was it. The drop shaft looked like new with smooth walls, and it didn't matter that we reduced the inner dimensions by one inch—the Maline Drop Shaft still has plenty of capacity.
