Utilizing Innovative Tactics and Trenchless Technology to Restore Critical Infrastructure

City of Omaha Missouri River Water Resource Recovery Facility

Matthew Hubel, PE, CPSWQ, LEED AP BD+C
The Schemmer Associates Inc.

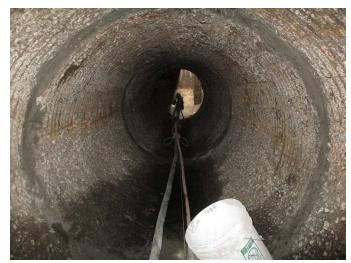
Circular channel prior to lining

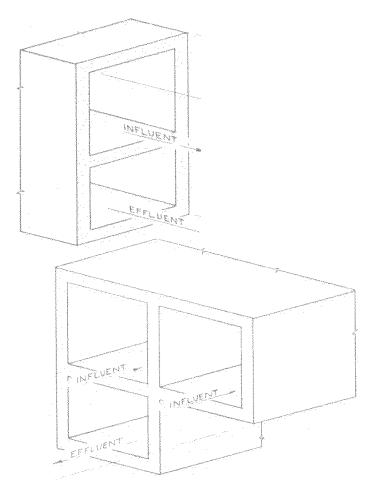
Isometric view of stacked channels drawing courtesy of Omaha Public Works, 1960

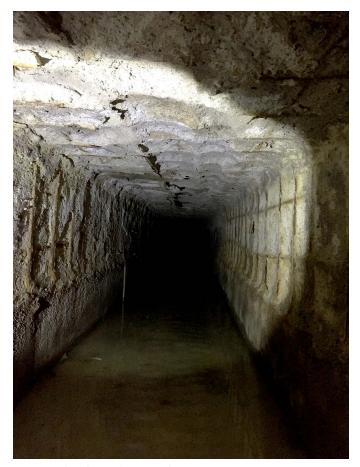
Rectangular channel prior to lining

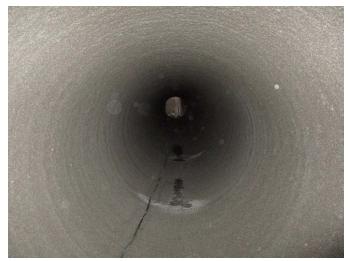
Circular channel after lining completion

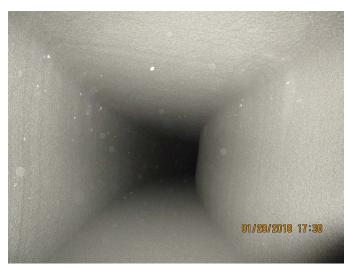
Radiused rectangular channel after lining completion
