Catching Up On Culvert Repair

Oregon Department of Transportation tests trenchless solution

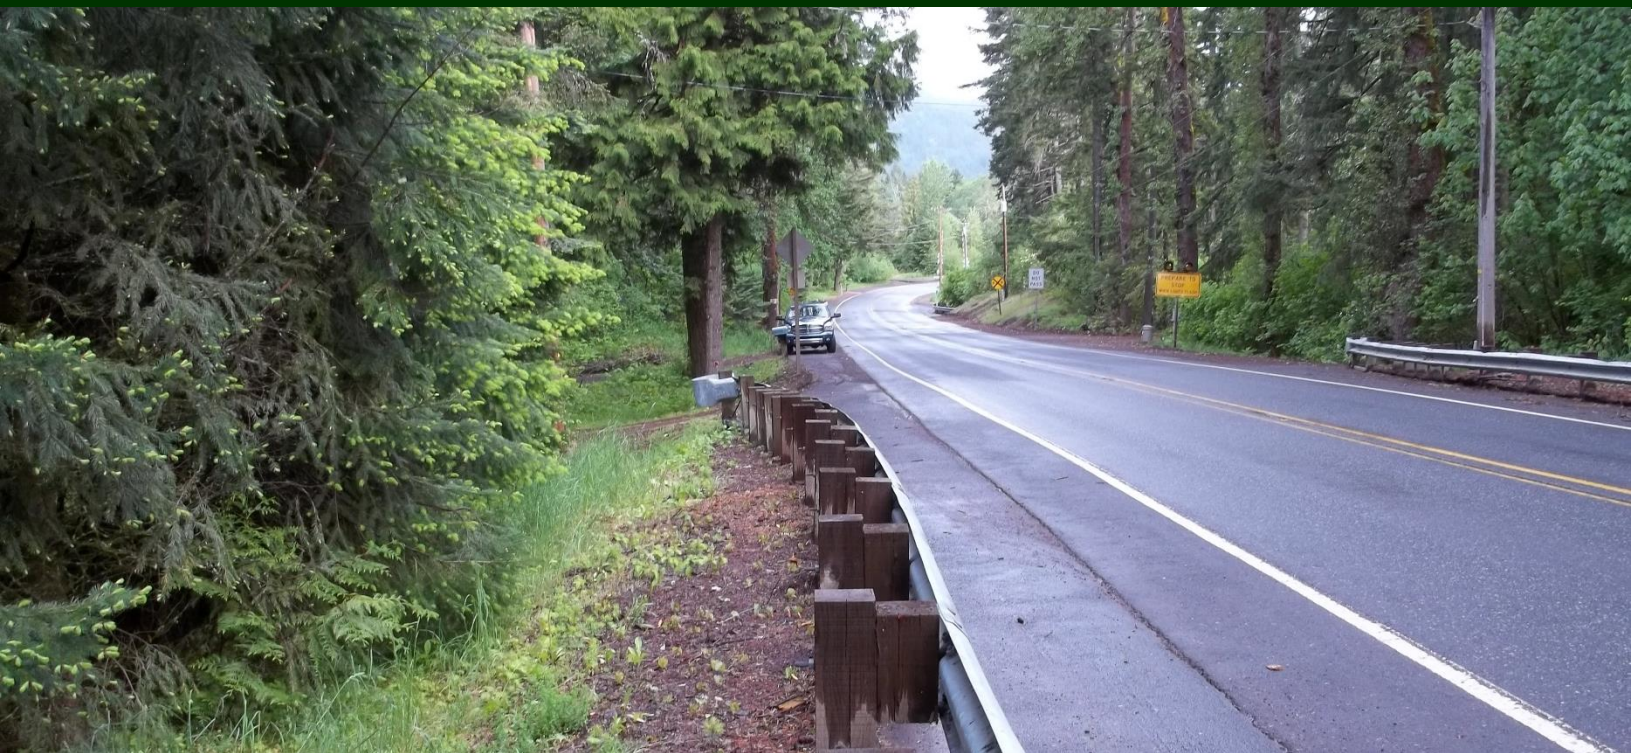
“When we actually got in the pipe and took a look, we found that it was worse than we thought,” Gunther said. Inverts were near failure or completely rusted out, and large voids were visible behind rotten patches for most of the culvert’s length. Oregon’s famous storm events also took a toll; rocks and sand pushed along by occasional high-velocity flows had damaged the CMP.

Before rehabilitation, the corrugated metal pipe showed signs of physical damage due in part to storms and debris pushed through by high-velocity flows.
