# Aurora, Colorado Saves Twin 96" Culverts and Major Arterial Roadway with Trenchless Solution

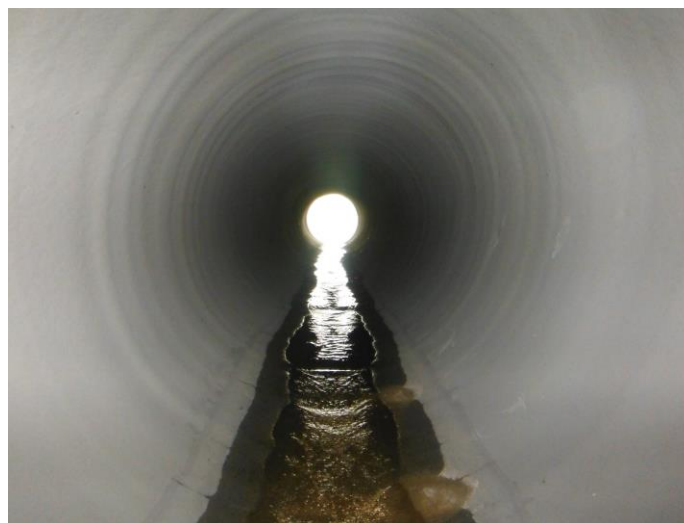
*96" Round Culvert After Centrifugally Cast Rehabilitation*

cleaning, invert repair, void grouting, storm flow diversion, and sand bagging to ensure any large storm run-off would not flood the nearby neighborhood. ACE Pipe Cleaning then applied the fine-aggregate cementitious CentriPipe liner, in 1/2" passes to attain the engineered design thickness.
